**CENTER FOR MARINE RESOURCES AND ENVIRONMENTAL
TECHNOLOGY and SEABED TECHNOLOGY REASERCH CENTER
UNIVERSITY OF MISSISSIPPI**

Activities Report for Cruise: GOM3-07-MC118, aboard the *R/V Pelican*
SSD/ROV 2nd Sea Trial Cruise

Mississippi Canyon Federal Lease Block 118, Northern Gulf of Mexico

July 2-8, 2007

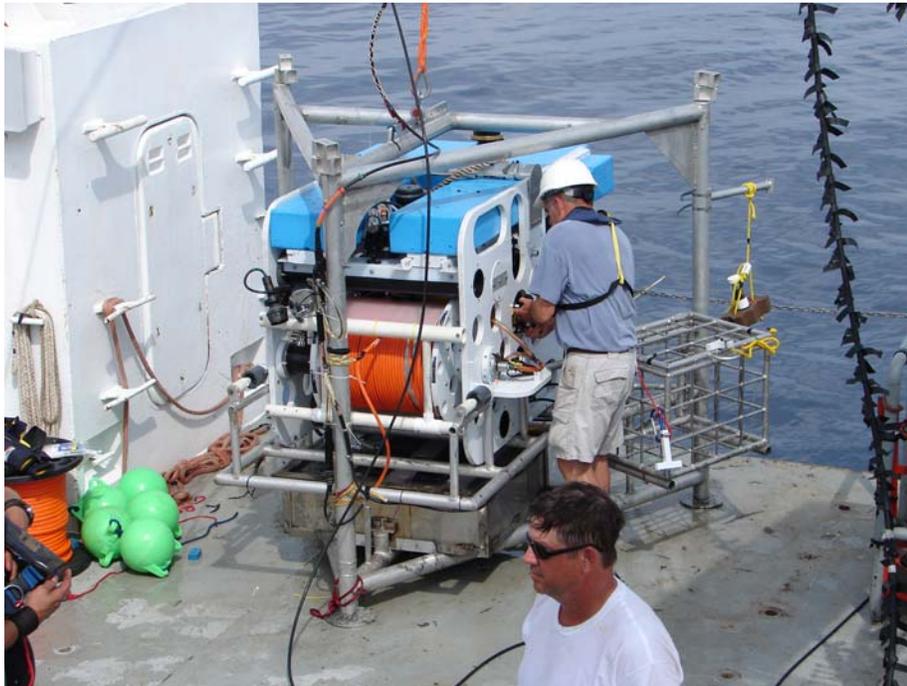
Figure 2. Paul Higley, SDI, checks out the SSD prior to deployment.

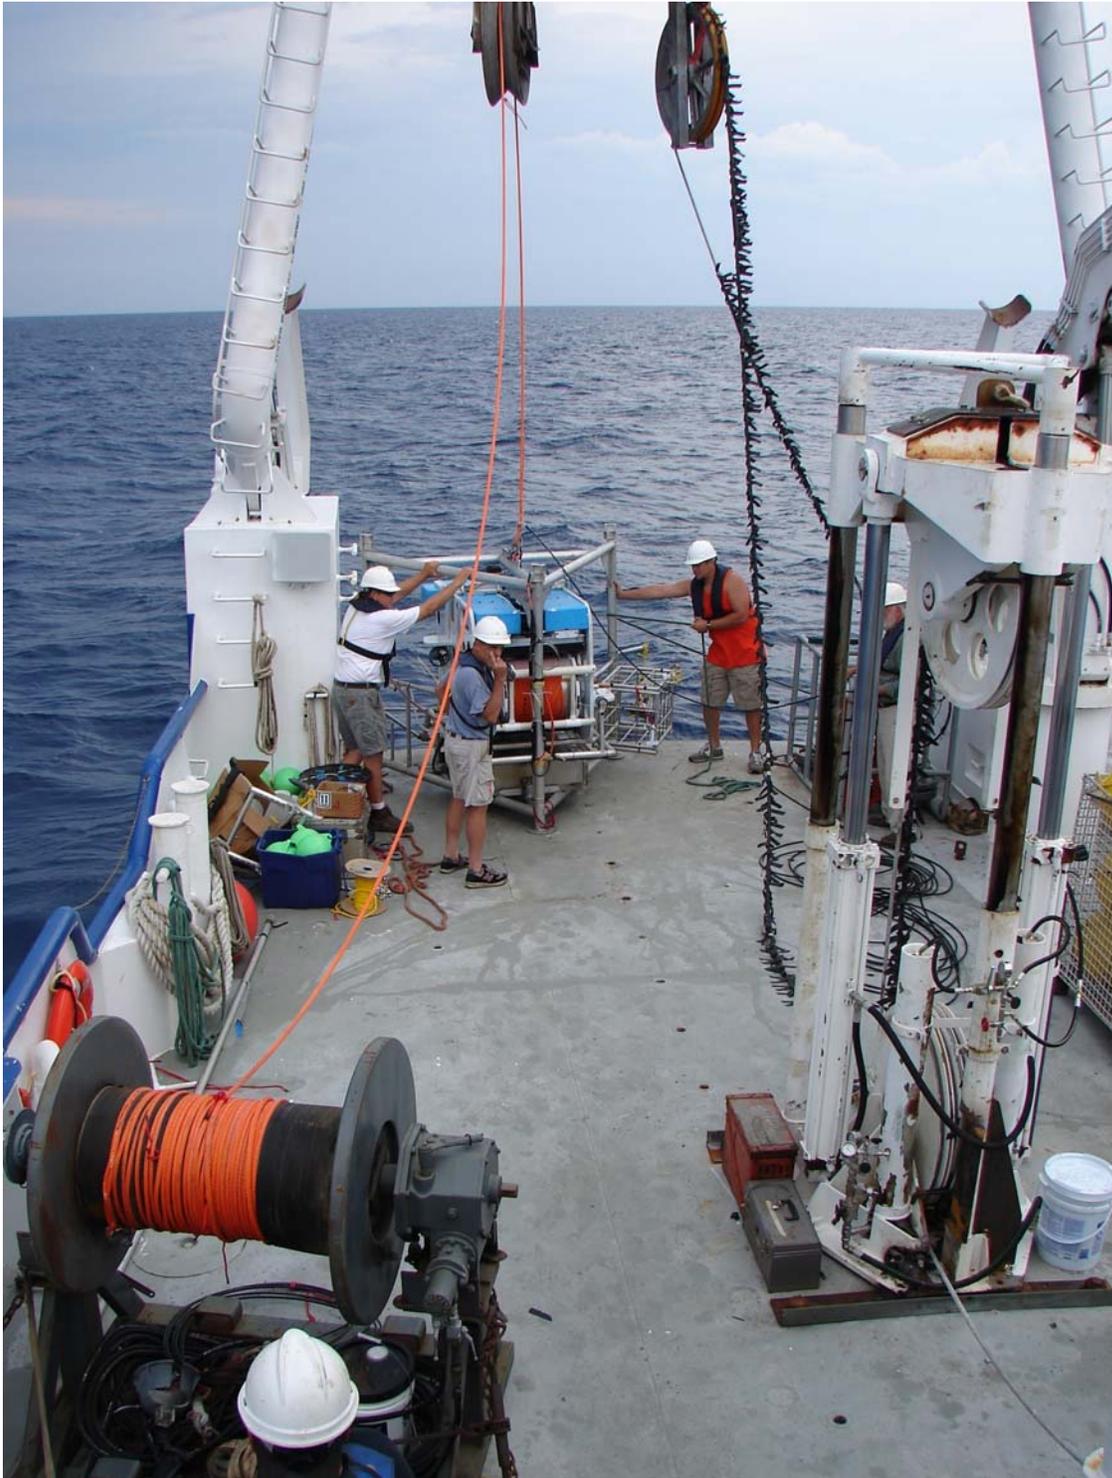
10:35: SSD/LC completed dry check out, lowered below surface for wet check out (see Figure 3). USBL system not functioning; dive aborted; SSD recovered on deck.

Figure 3. SDI and CMRET teams prepare to deploy the SSD followed by the mid-water weight. Note that the cable to the mid-water weight is threaded through the heave compensator and that the cable by which the SSD will be deployed is not.

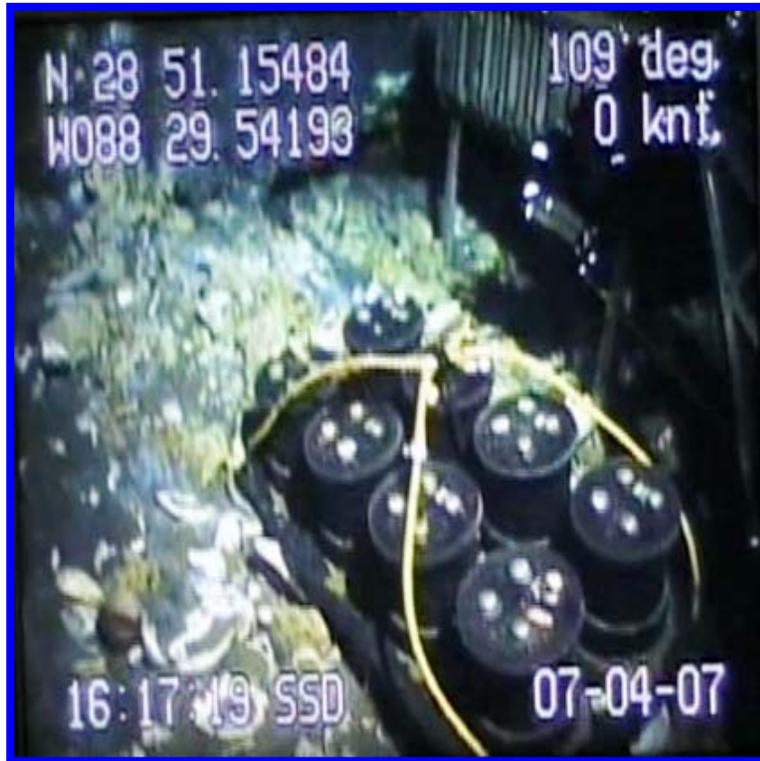
Figure 6. SSD retrieving the Biolec. Flashing confirmed *via* the SSD's camera.

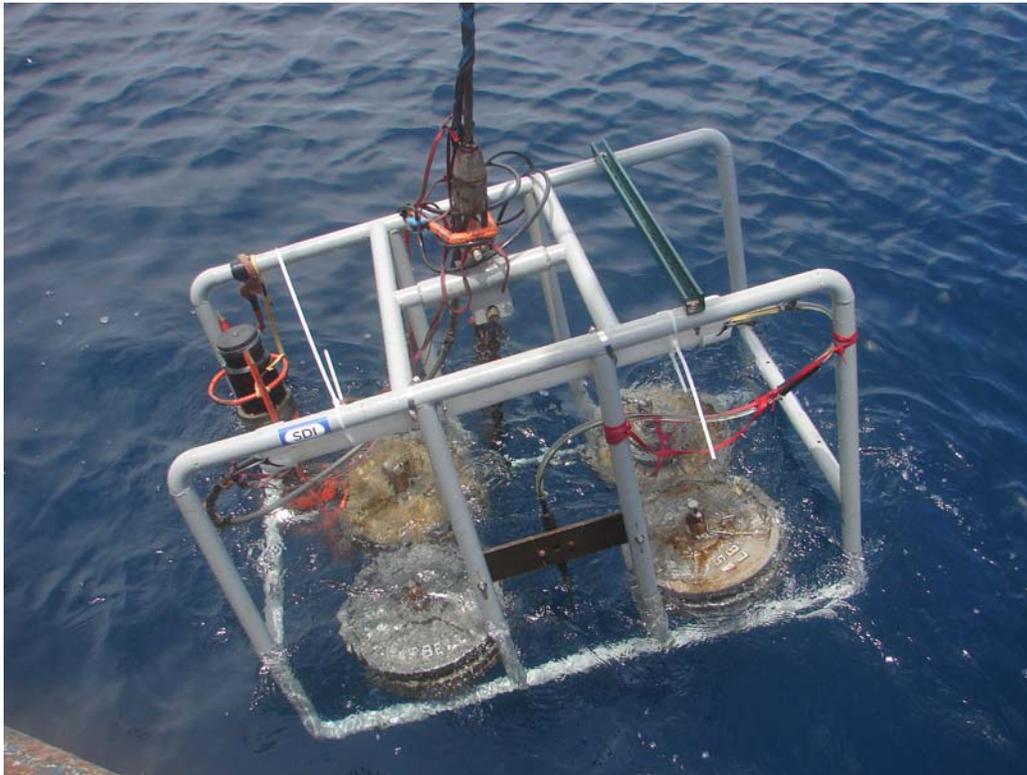
Notes on Dive #7. 1) While the SSD was maneuvering around the sea floor damage was detected in the winch actuator apparently a result of the Dive #6 tether wrapping on the winch axle. A clutch which will limit the maximum force that is transmitted to, or developed by, the actuator will be needed for the future to prevent damage to the actuator. 2) The optical link was lost part way up during recovery and regained later during recovery. 3) The Cortland Fiber optic line had become fouled on the DeepSee mid-water weight and far exceeded the allowable minimum bend radius. 4) The link recovered once the stress on the Cortland cable was diminished. A change in the spacing and application of weights and floats to this mid-water weight will prevent this from re-occurring.

Figure 7. Deployment of the mid-water weight that stabilizes the SSD by buffering it from the heave and pitch action of the ship via the tether.
